Prairie Mountain East Meadow Restoration Area T. 15 S., R. 7 W., Sec. 4

<u>Meadow Site Description – Mary's Peak Resource Area, Salem District BLM</u>

Landmark Name: East Prairie Mtn.

Legal: 15-7-4 Date: 9-25-02

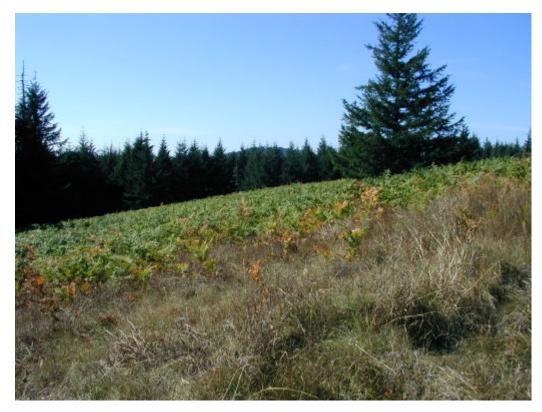
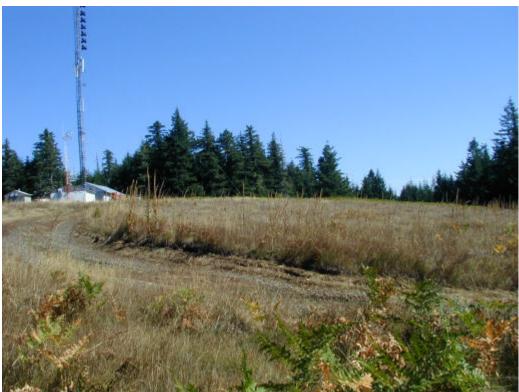
Prairie Mountain East Meadow Restoration Area, T. 15 S., R. 7 W., Sec. 4

This is a mesic site dominated by grasses and bracken fern. Conifer encroachment is minor. There is an opportunity to diminish bracken fern cover and increase other native plants. Communication equipment on the site will require protection.
